Re: Greenway Exit 5 cell tower buffer — SPEX 2009-0030

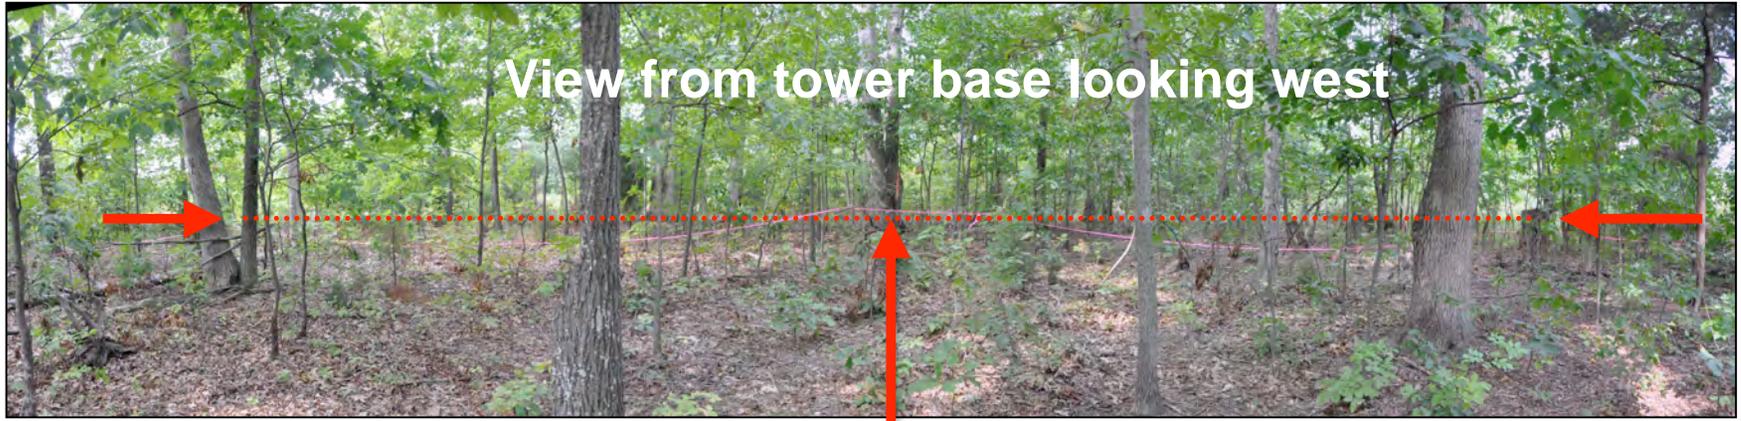
Entrance to facility comes through here from the exit ramp

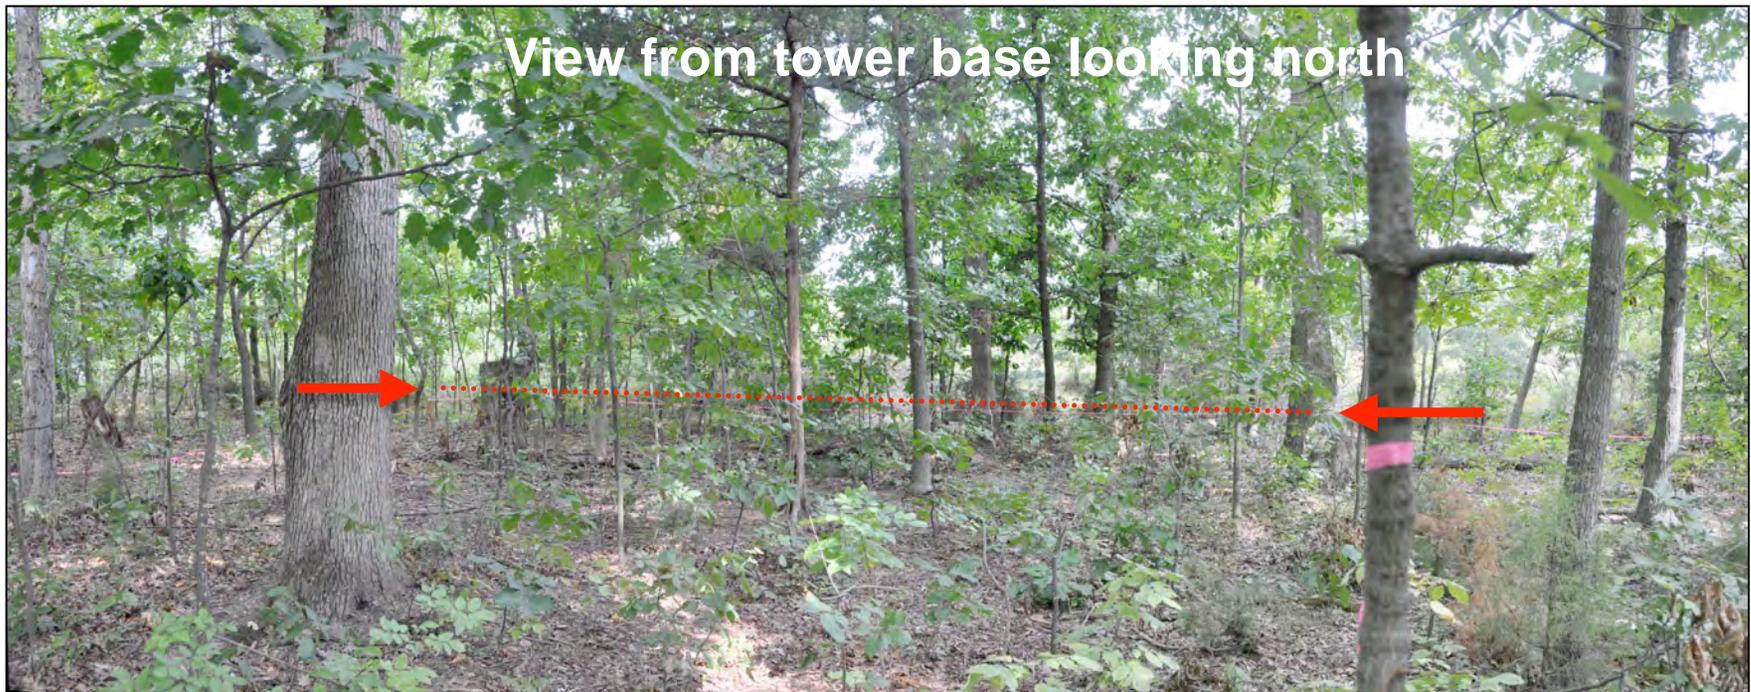
Limits of clearing and grading indicated by red dotted line, from arrow to arrow

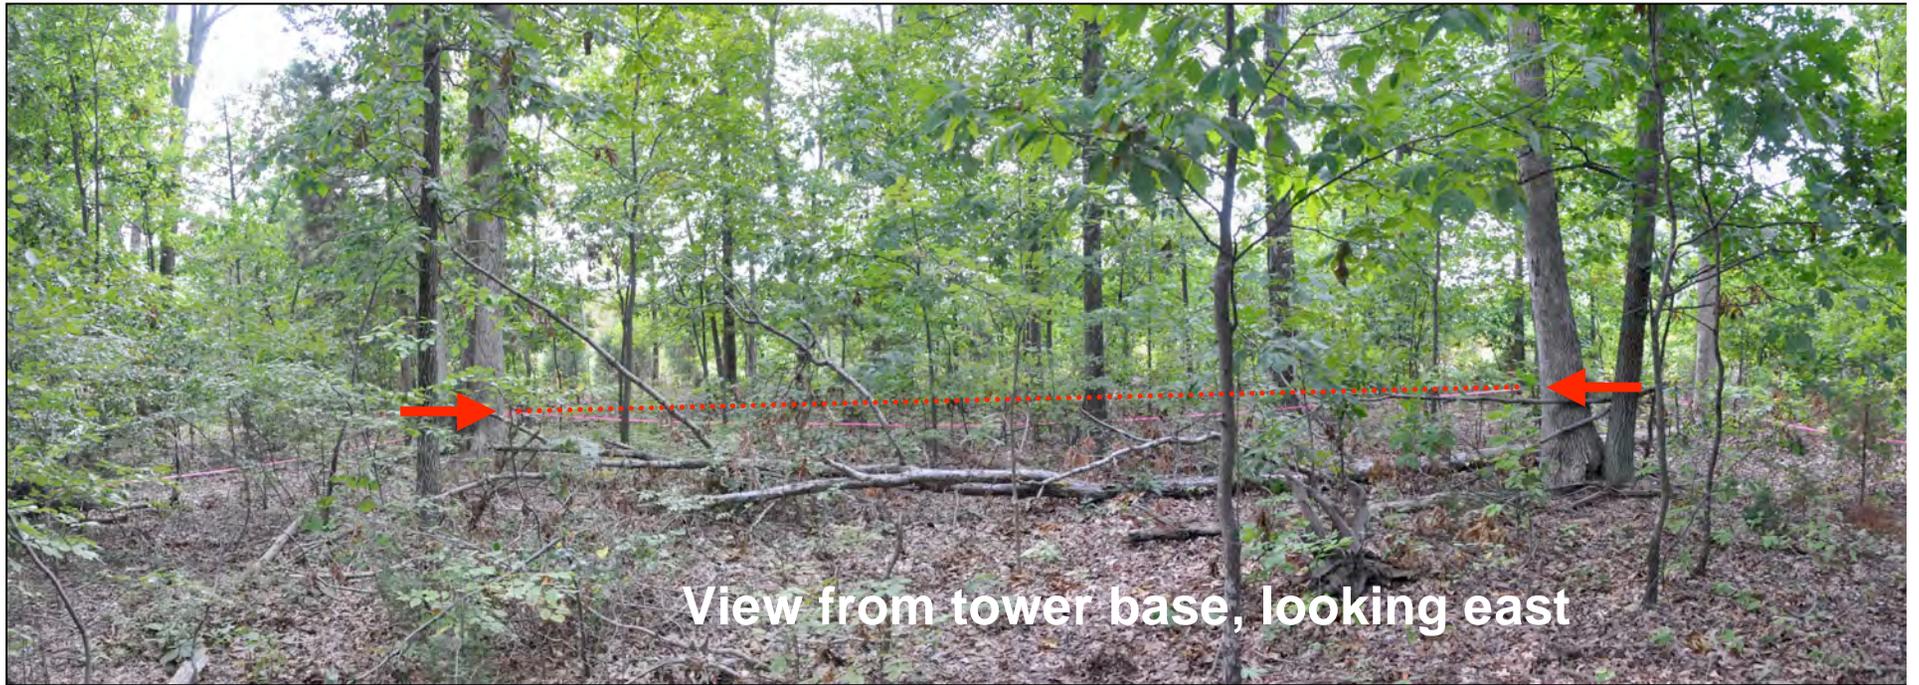
View from tower base, looking east

Limits of clearing and grading indicated by red dotted line, from arrow to arrow

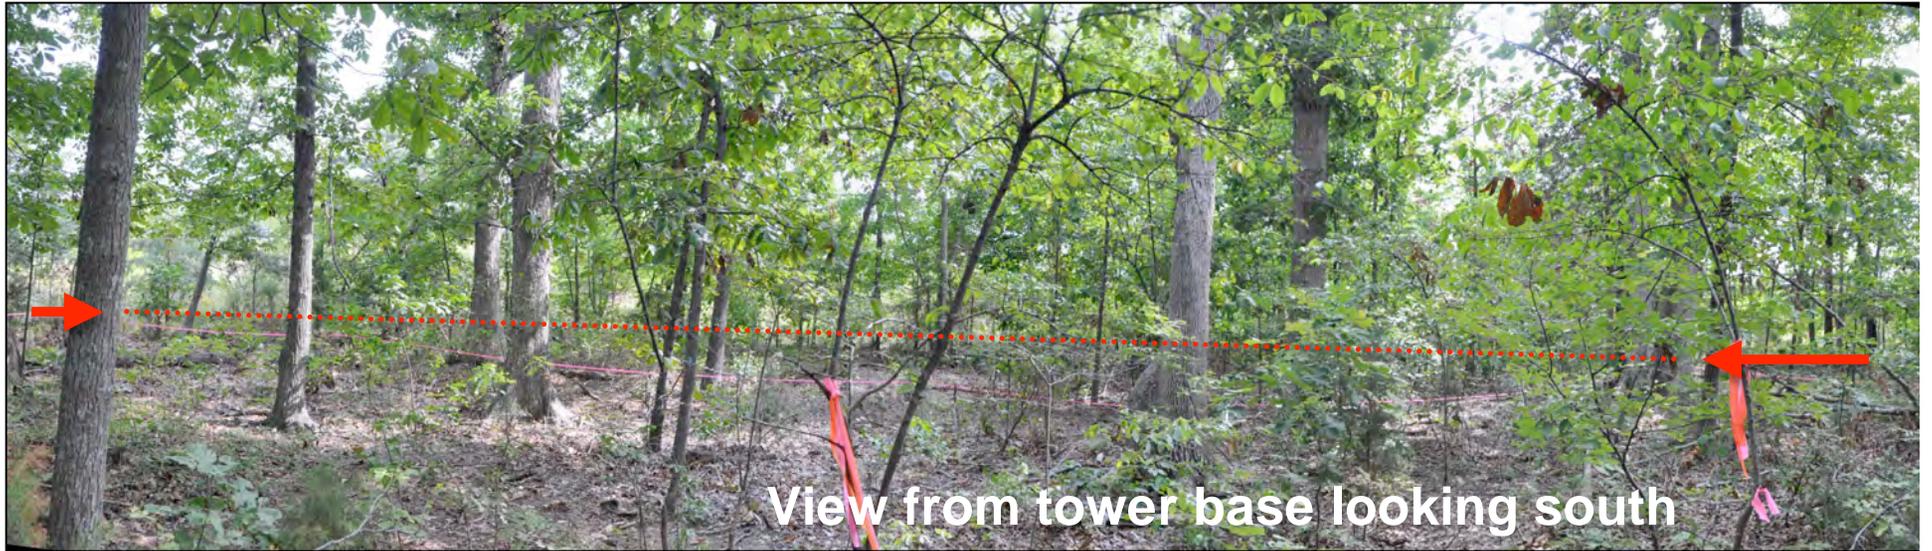
Limits of clearing and grading indicated by red dotted line, from arrow to arrow
