**Historic District Review Committee
Staff Report
Date of Meeting: September 12, 2011
CAPP2011-0010
Historic District: Waterford
Project Planner: Lauren Murphy**

CAPP 2011-0010 McGuire: Installation of wood porch railing and removal of existing second story balcony. PIN # 303-26-6235. Second Review.

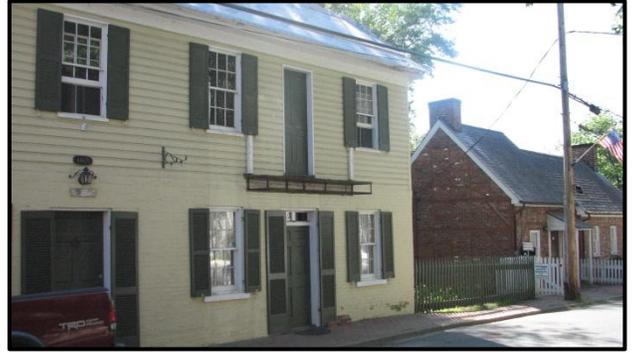
Photo 1: Subject Property, 40171 Main Street, Waterford

The application proposes a minor modification to the existing second story doorway with the addition of a wood railing. The existing balcony has deteriorated and fallen off the building. The applicants' statement of justification (SOJ) indicates that all remaining fragments of the balcony will be removed and the siding will be repaired or replaced in kind (no CAPP required). The new wood railing will be mounted outside the door jambs and will not significantly alter the form

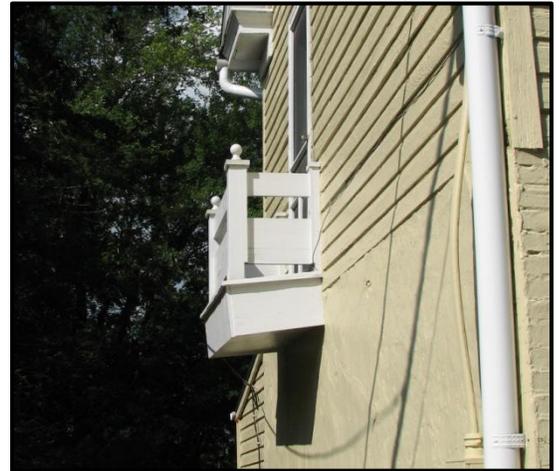
Photo 2: Existing side balcony

across the second story entryway which was not approved by DHR. The applicants have since amended their application and now propose to construct a wood railing matching the railing on an existing balcony on the South elevation. DHR has approved this revised request (see included letter).

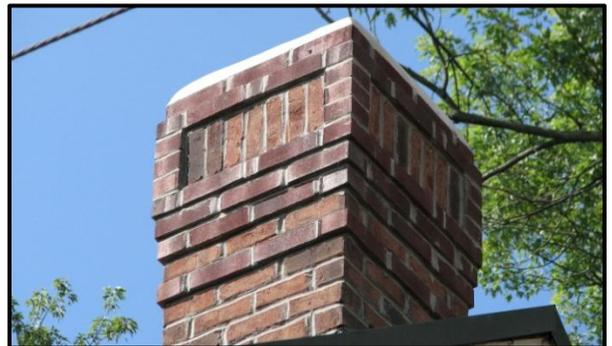
Photo 3: Revised Chimney Design

The applicant is seeking retroactive approval for work that has been done to restore the gable-end chimneys. As the project was originally intended to be repair in-kind, no CAPP application was needed. However, during the repair work, the applicants' mason rebuilt the chimneys with more detailing in the brickwork than was originally intended. The applicants have included an explanation of the alterations to the chimneys as well as before and after photos.

The Guidelines for existing chimneys state that repairs to existing chimneys should “match the original materials, colors, shape, and masonry as closely as possible” (Waterford Guidelines, Guidelines for Existing Structures: Elements, Chimneys, page 91, Guideline 2). The revised chimney design matches the color and materials of the chimney but has incorporated recessed panels of brick inlaid with solid courses, a detail that is not characteristic of the Waterford district. Prior to the repair work, the chimneys had been covered in stucco. The revised design is inconsistent with the Guidelines for repairs to existing chimneys because of the decorative detailing that was added.

1. The previous chimneys were covered in stucco and painted similar to the siding on the house.
2. The design details of the restored chimneys are not consistent with the Guidelines for existing buildings which support repair and replacement in kind.
3. DHR has approved the chimney restoration with the condition that the chimneys are re-covered in stucco and painted.

The Department of Historic Resources has requested that the applicants re-cover the chimneys in stucco and paint them in order for the completed work to be consistent with the Secretary of the Interior’s *Standards for Rehabilitation* (see included letter from DHR). As the Guidelines support the repair/replacement in-kind of existing brickwork and chimneys, this treatment of the chimneys is consistent with the Guidelines. **Staff recommends a condition of approval that the chimneys be re-covered in stucco and painted, to match their previous design.**

Staff recommends approval of the revised wooden railing as submitted in the application and approval of the revised chimneys with the condition that they are re-covered in stucco and painted. Please note that two separate motions have been provided below.
