# **Archaeological Identification for Site 46, Algonkin Regional Park Loudon County, Virginia.**

**Archaeological Identification for Site 46  
Algonkian Regional Park  
Loudon County, Virginia.**

**Project Location and General Description**

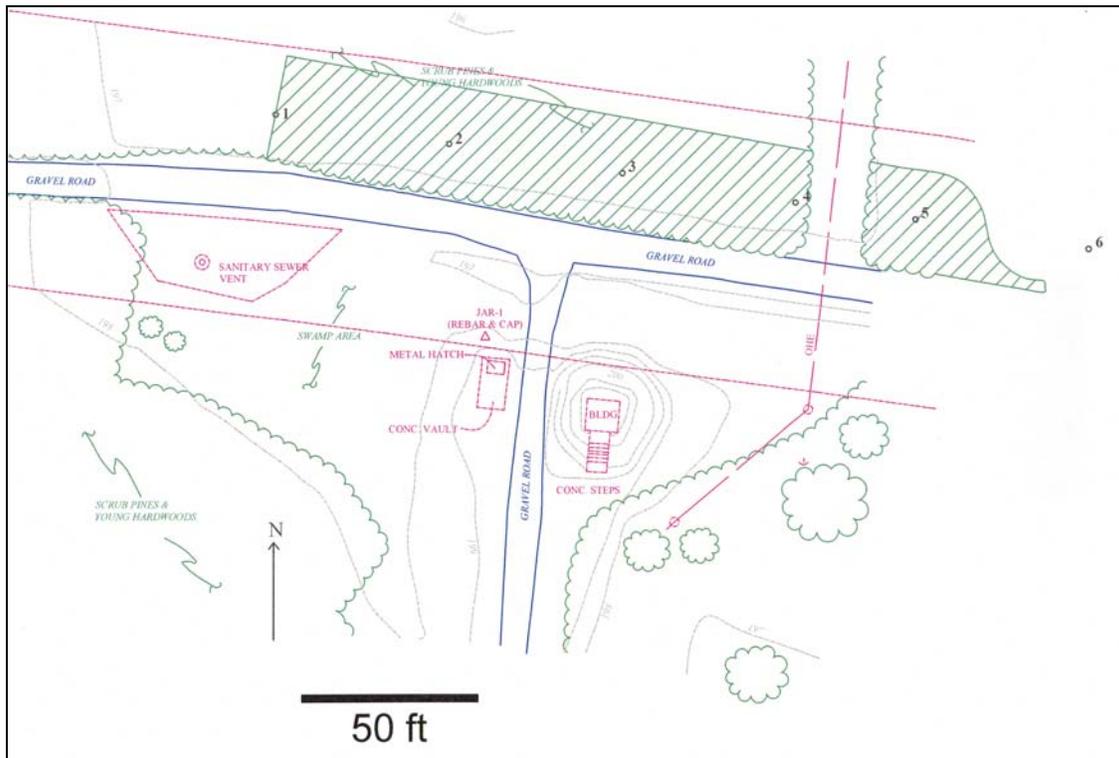
Figure 1. Site 46 map and shovel tests 1 through 6.

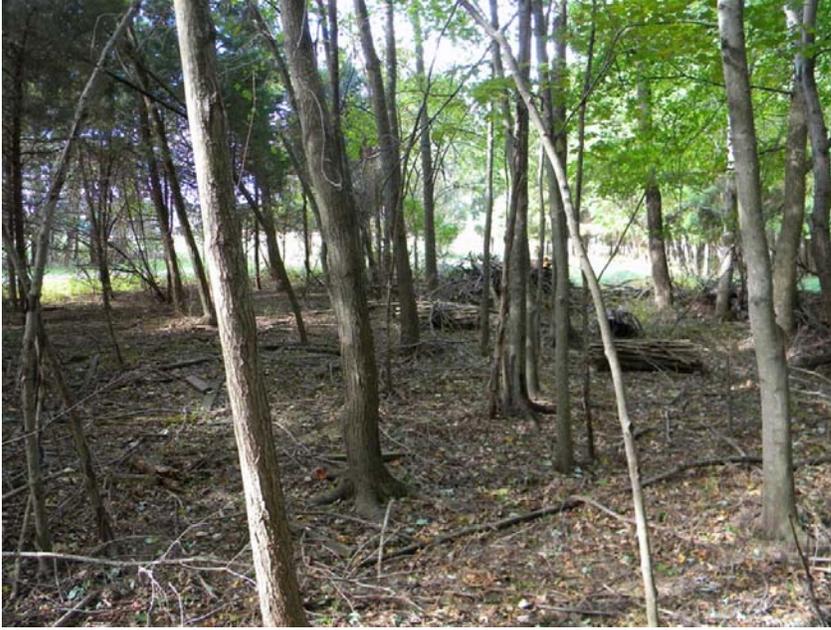
The site is located within Algonkian Regional Park east of Fairway Drive in Sterling, Virginia. Site 46 is 10,890 square feet (0.25 acres) and is bounded by forested land to the west, north and east, and a gravel hiking trail to the south (see Figure 2). The site is owned by the Northern Virginia Regional Park Authority.

Figure 2. Site 46, looking southwest.

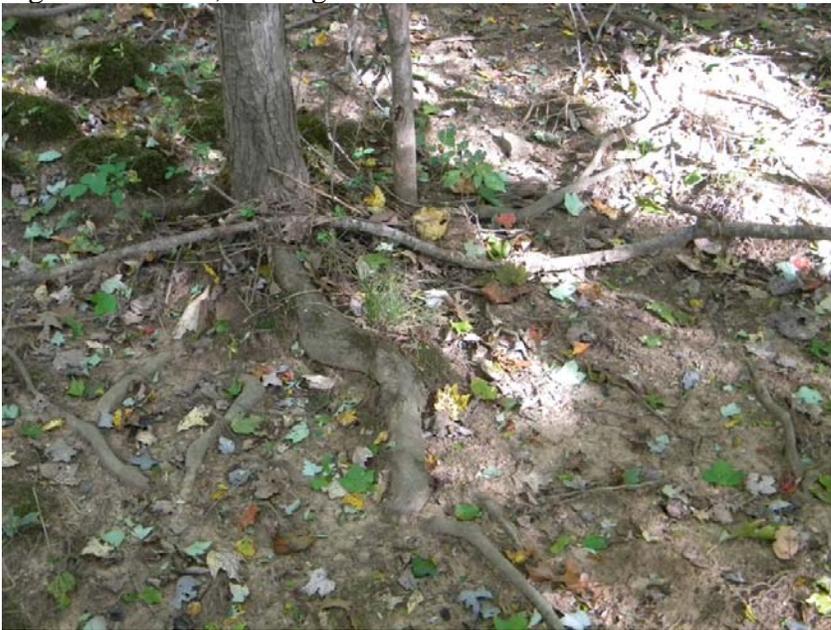
Site 46 slopes very gently down to the north. Recent growth covers what likely was part of a cultivated field. Stormwater, largely from the south, has washed the surface, removing sediment and exposing tree roots (Figure 1 through 3).

Figure 3. Site 46, washed surface and exposed tree roots.

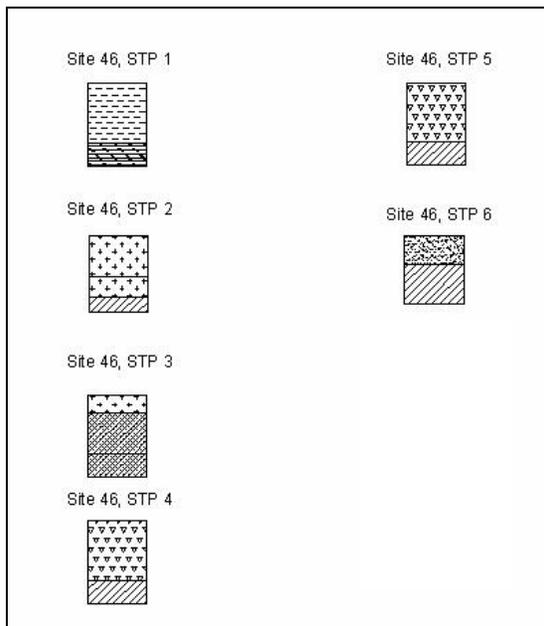
At Site 46, six shovel test pits were dug (Figure 4, Table 1). Stratum 1 ranged from 0.3 ft to 1.0 ft in thickness. The soils in Stratum 1 were 10YR4/3 silty loam and silty clay; 10YR5/4 and 7.5YR4/6 silty clay loam; and 5YR4/3 clay loam. Stratum 2 ranged from 1.0 ft to 1.4 ft below grade. The soils were: 10YR5/3 silty clay loam; 7.5YR4/4 silty clay; and 5YR7/1 and 10YR5/4 clay. Stratum 3 appeared in STPs 2 and 3 only and went from 1.3 ft to 1.4 ft below grade. The soil was 10YR5/6 clay and 7.5YR7/3 silty clay. In all six of the STPs the soil of Stratum 2 and 3 were redox, suggesting poor drainage. No cultural material was found.

Figure 4. Shovel test soil profiles for Site 46
