Historic District Review Committee

Staff Report
July 12, 2010

CAPP 2010-0016 Ortiz-Bell: Remove Front Deck and Replace with Front Porch in the Goose Creek Historic District: PIN 491-27-7785.

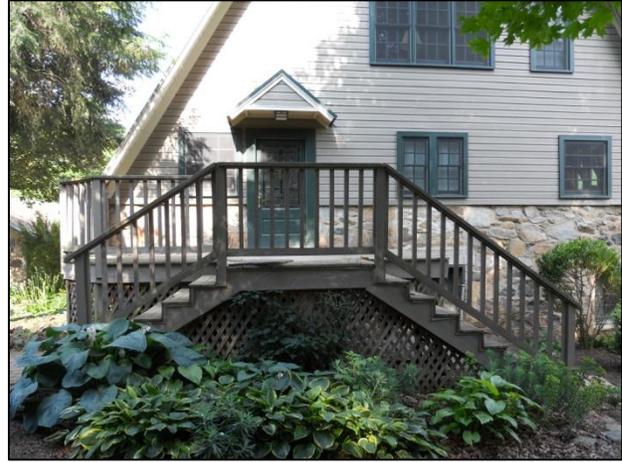
Photo 2: Deck proposed for removal at 37285 Bolyn Road.

The applicant proposes to remove a deck constructed in the 1970s and expanded in the 1980s that serves as the front entry into the converted barn. The applicant states in the Statement of Justification (SOJ) that the deck is in need of repair and the entry porch does not provide enough protection from the weather. The intent is to replace the deck with an entry porch that has a smaller floor area and is entirely under roof.

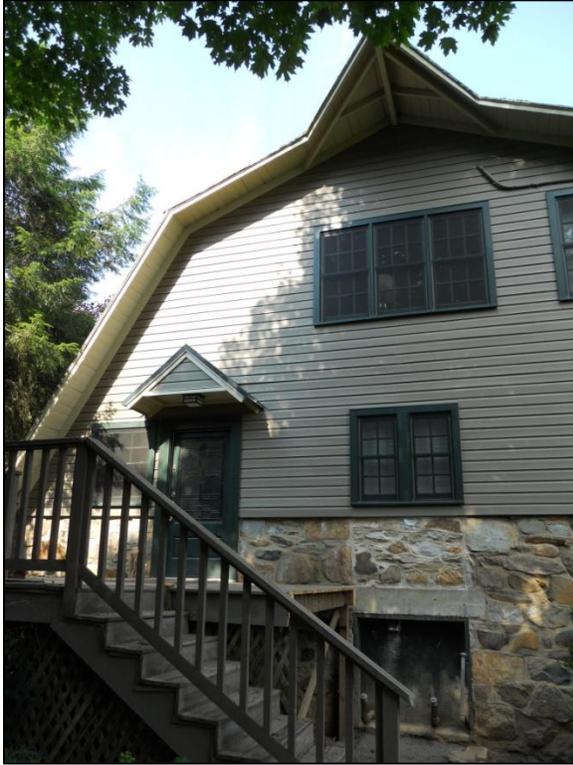
Photo 3: Roof overhang details and balustrade at 37285 Boly Road.

To further create a design connection with the historic barn, the applicants state in the Additional Question responses that they will be incorporating details into the porch roof found in the eave overhang of the barn (Photo 3). The gable will have a 12-inch rafter overhang and an 18-inch deep eave that will both be left open to expose the roof structure. Exposed structural elements include 2-inch by 8-inch rafters and tongue and groove roof decking that is similar in dimension to the existing roof decking. Incorporating architectural details found on the historic barn meets the Guidelines for

The balustrade on the porch and steps will match the existing balustrade (see Photo 3). The balusters will be pressure treated pine and spaced less than 4 inches apart. The posts will be 6-inch-by-6-inch pressure treated pine posts. The balustrade design and simple posts are appropriately utilitarian and do not attempt to incorporate more highly styled porch elements, meeting the Guidelines. The posts and balustrade should be painted or stained in a color scheme that matches the house to meet the Guidelines.
